Mahalo North Coal Seam Gas Project – Aquatic Values Assessment

July 2023

Prepared for:
Epic Environmental Pty Ltd
Level 17, 95 North Quay
BRISBANE QLD 4000

Prepared by:
DPM Envirosiences Pty Ltd
ABN: 54 602 226 460
PO Box 1298, Mooloolaba QLD 4557
Ph: 0427 694 433

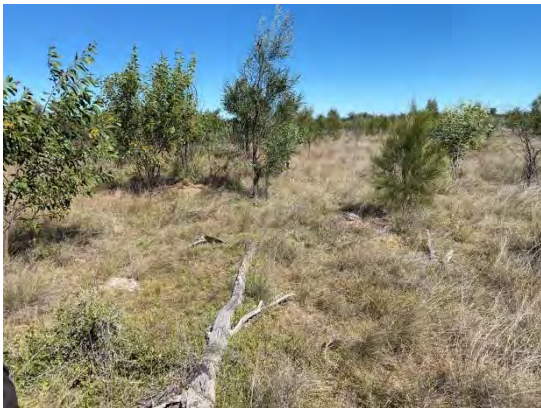
Site HES2 – looking west/downstream, 17/08/2022

Field verification at sites HES2, R1, R2, R7 and R13 (Plate 5) found no evidence of groundwater expressions, salt seeps, hydrophytes or other on-ground indicators of being a GDE (Appendix B). The health, apparent moisture levels and extent of riparian vegetation was consistent with other waterways of the Study area not mapped as potential surface expression GDEs.

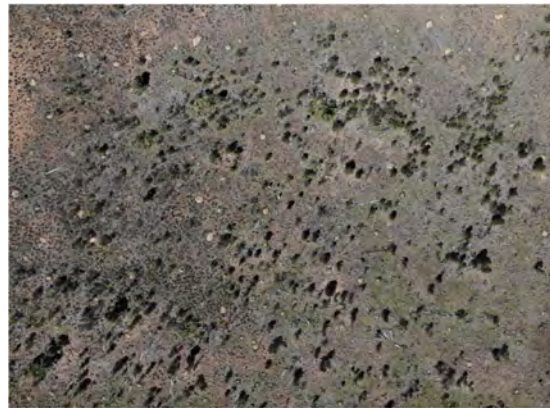
Site HES2 – aerial/drone photo from 120 mAGL
